## STRUCTURAL CONCEPTS

### **DEGENKOLB ENGINEERS**

The structural work for the conversion of the Laundry Building to the Historic Boat Museum consists of a seismic retrofit and building addition. The existing additions around the building will be removed.

GRAND CANYON RIVER HERITAGE MUSEUM  
LAUNDRY BUILDING MAIN LEVEL

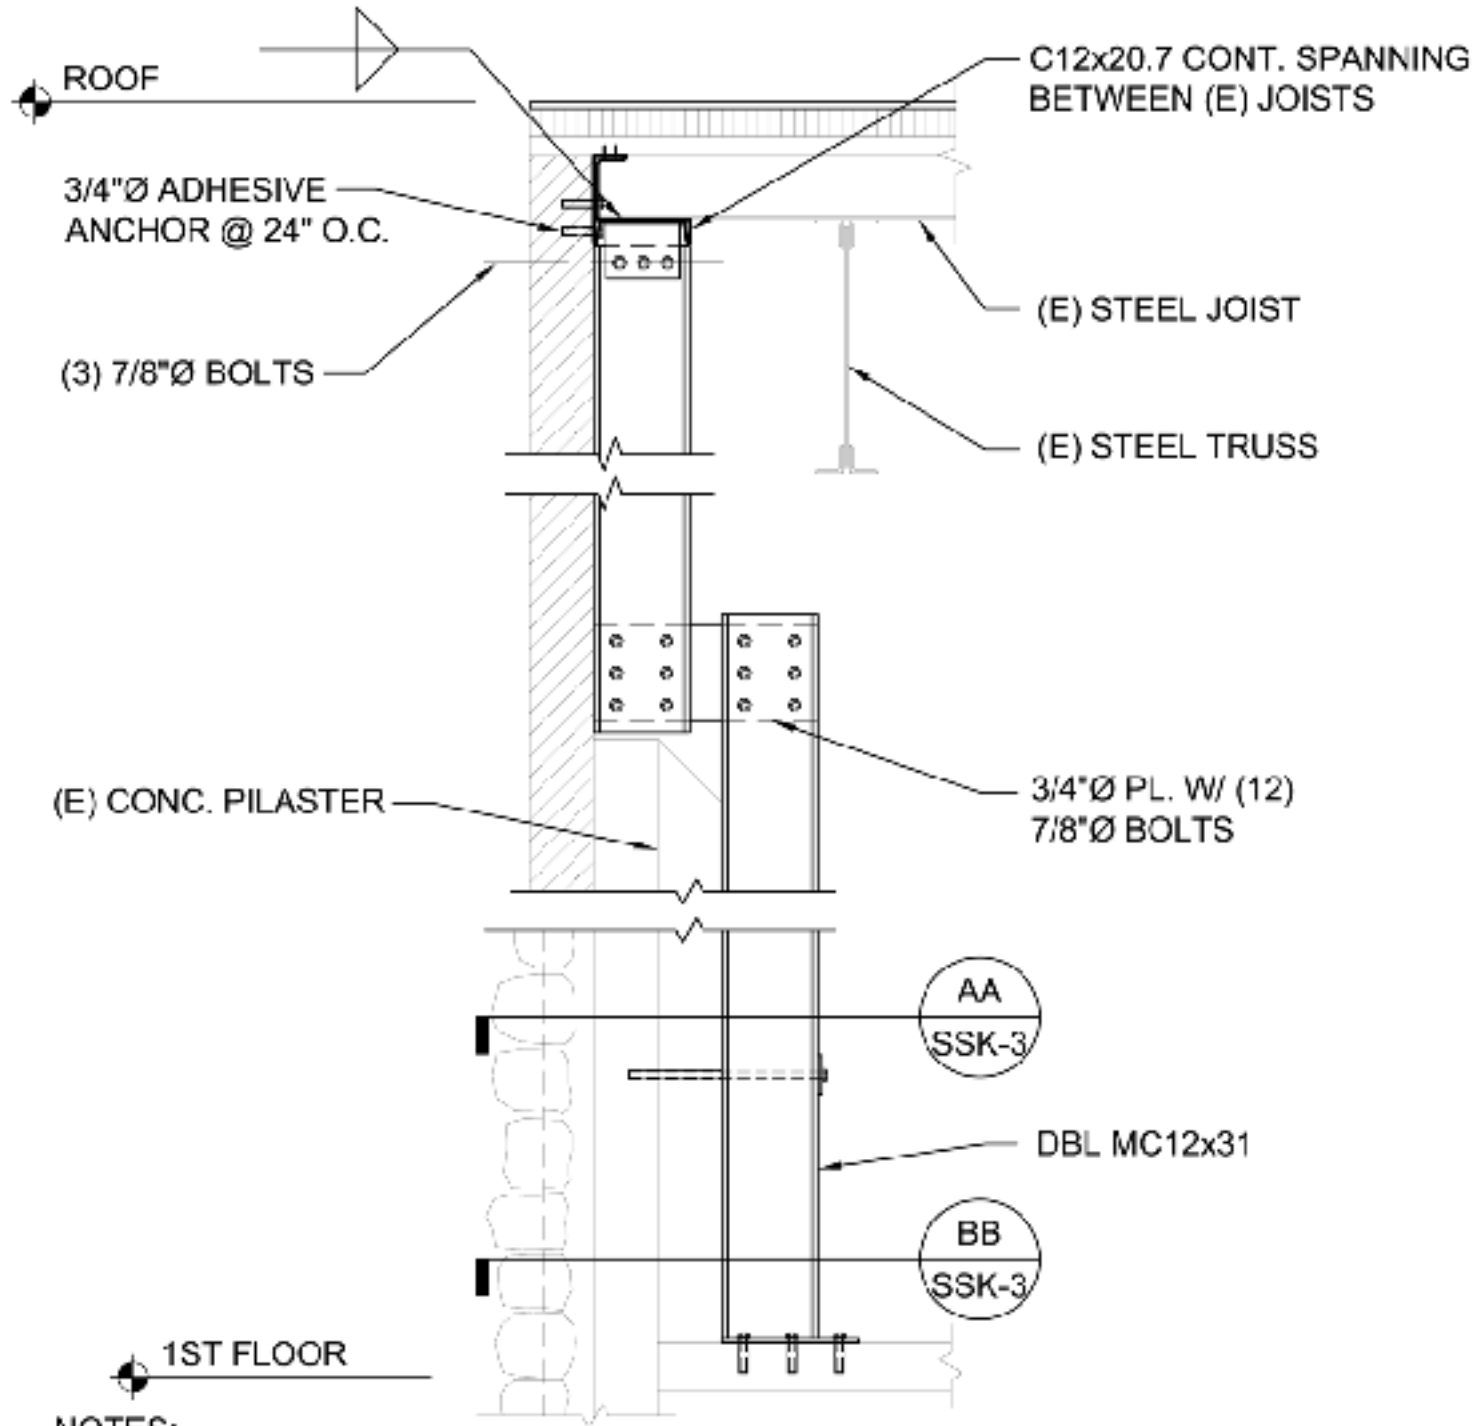
1. ALTERNATELY, PLACE VERTICAL CHANNELS ON EACH SIDE OF (E) PILASTER. IN THIS CONFIGURATION, SPLICE IN CHANNELS CAN BE ELIMINATED.
2. ON NORTH AND SOUTH WALLS, INSTALL C12 ON UNDERSIDE OF DECK AND ATTACH TO EXISTING 2x3's SIM. TO SSK-4.

**SSK-2 WALL STRONG BACK**

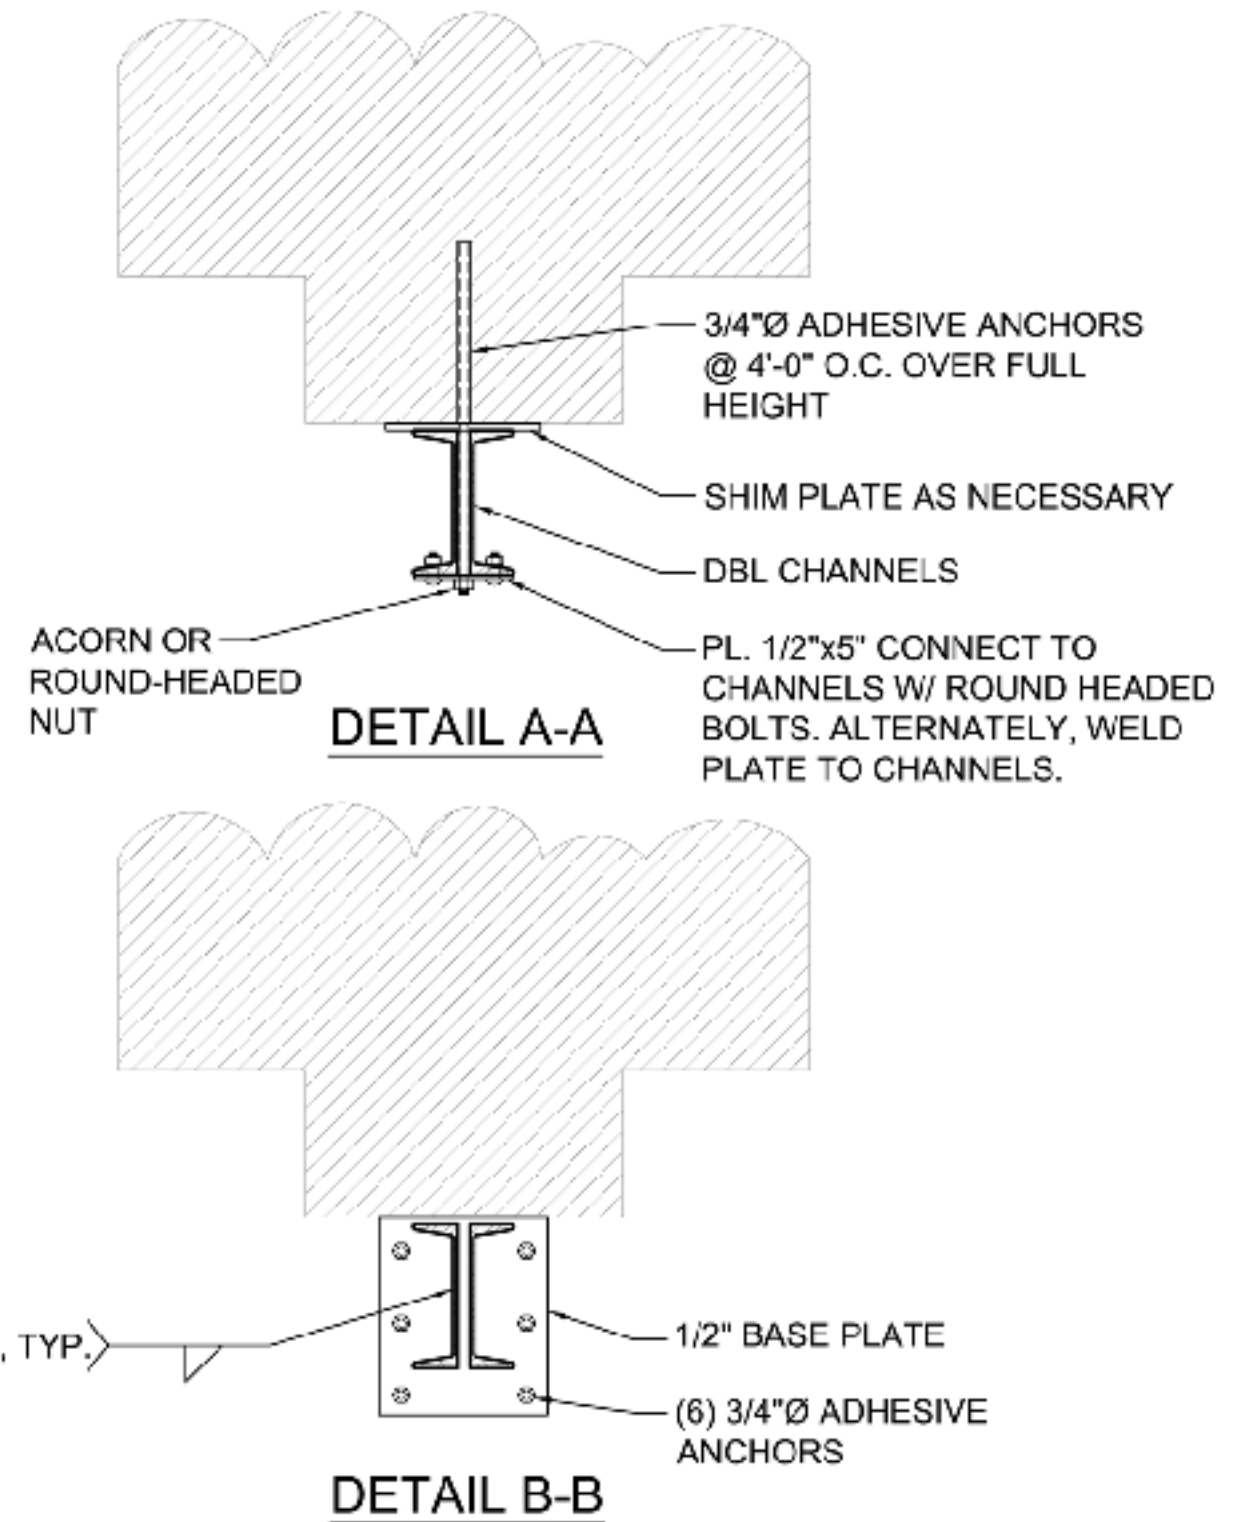
**SSK-3 WALL STRONG BACK SECTIONS**

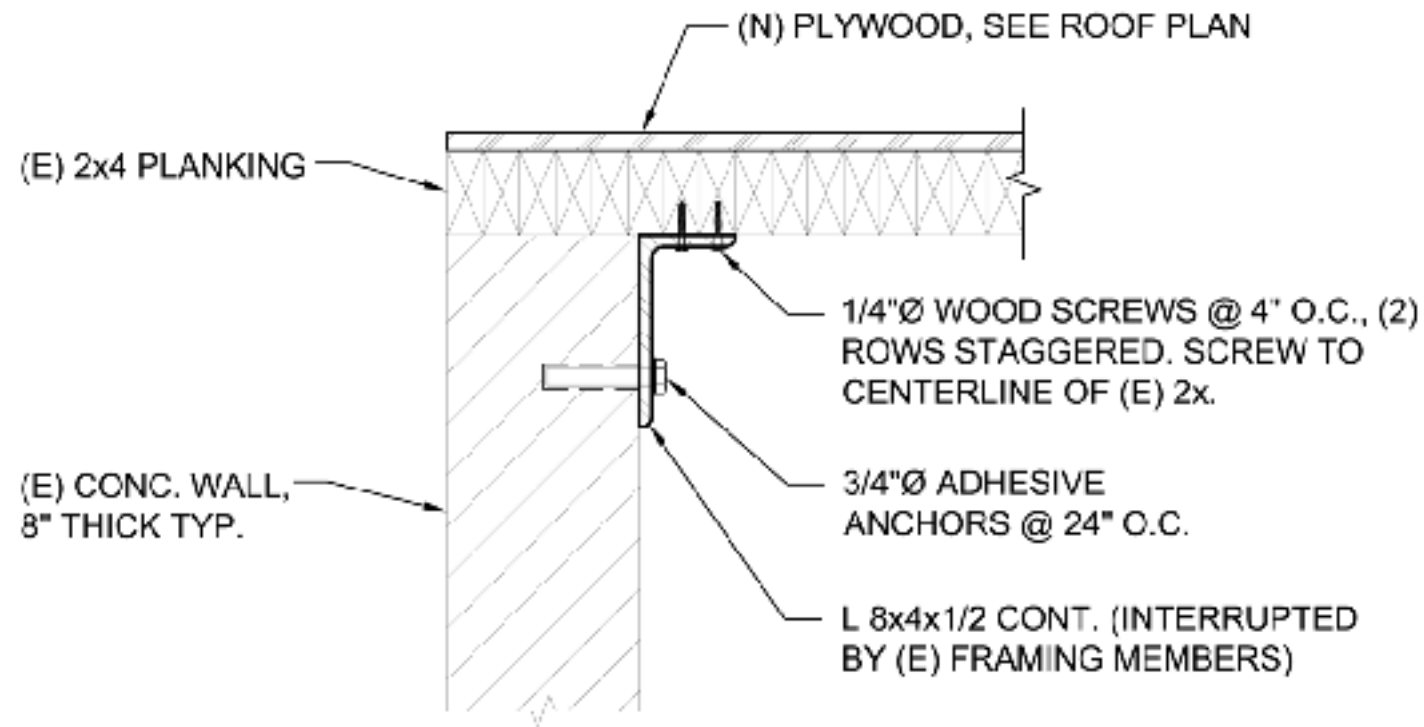
**SSK-4 SHEAR TRANSFER CONNECTION BETWEEN DIAPHRAGM AND WALL**

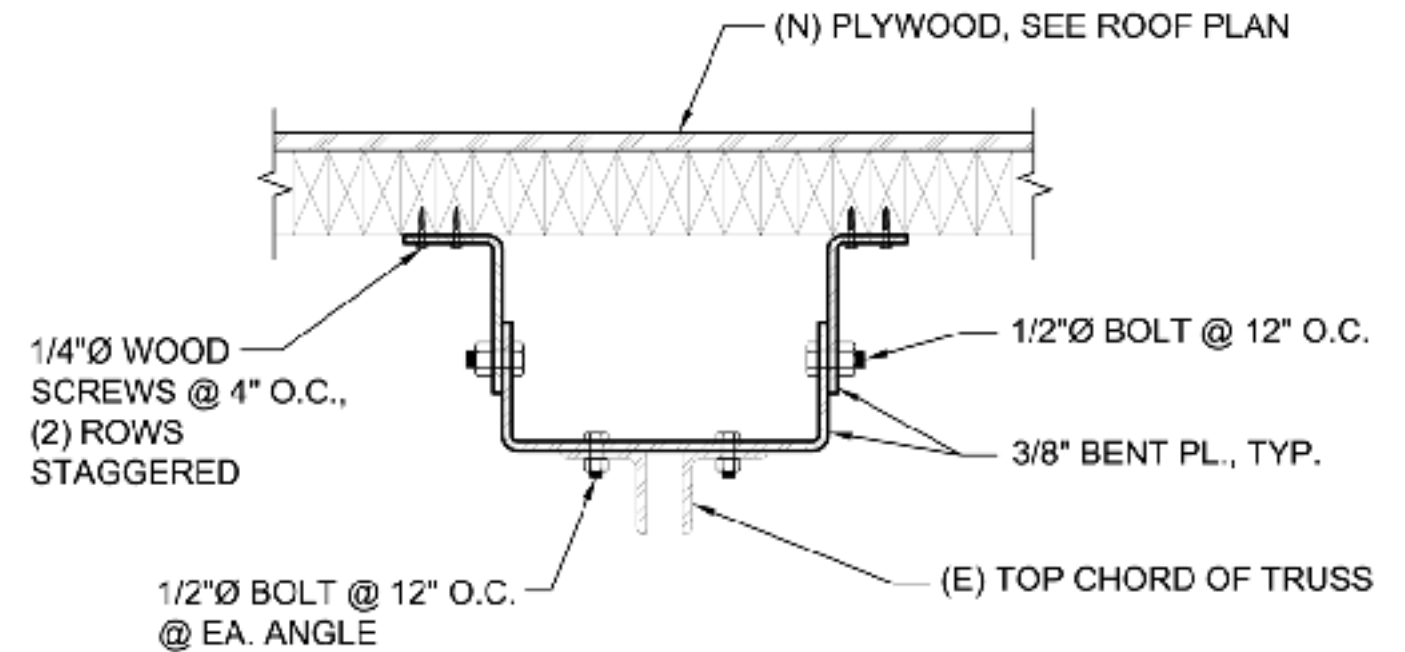
**SSK-5 TRUSS TO DIAPHRAGM CONNECTION**

**NOTE:**  
ALTERNATELY, PROVIDE WELDED CONNECTIONS IN LIEU OF BOLTED CONNECTIONS.
